MOORING CHAIN CLIMBING ROBOT FOR NDT INSPECTION APPLICATIONS

Inspection of mooring chains is a dangerous and costly procedure covering inspection above and below the waterline. The paper presents initial results from the RIMCAW project which was aimed at designing and building an inspection robot able to climb mooring chains and deploy NDT technologies for scanning individual links thereby to detecting critical defects. The paper focuses on the design and realisation of the inch worm type novel crawler developed and tested in the TWI Middlesbrough water tank.

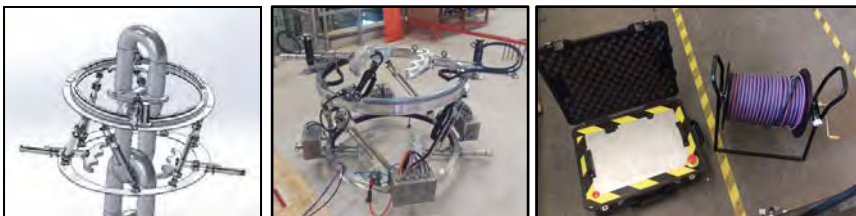
Figure 5 - Detailed Mechanical Design

The final RIMCAW robot design and actual robot is shown in Figure 5; this was based on a standard Stewart platform, comprising six prismatic actuators attached in pairs to three positions on the platform's baseplate, crossing over to three mounting points on the top plate. This design allows the robot to control the pitch, roll and yaw of the top and bottom baseplates. This controllability of the platform's crawling orientation is crucial as it needs the robot to traverse the various catenary curves of mooring chains likely to be found in real scenarios. In addition, this configuration allows the robot to contract and expand allowing it to crawl by inch worming along the chain links. The method of positioning and securing the robot onto the mooring chain structure had been extensively studied and a latch/ hinge system was incorporated into the design to allow simple opening of the simplify the deployment process for end user.

a) Final detailed CAD model

b) Actual RIMCAW robot

c) Command station and umbilical

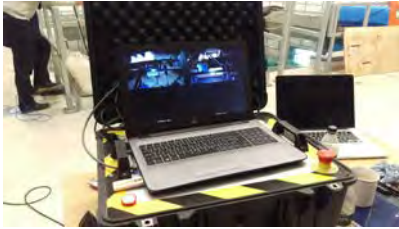
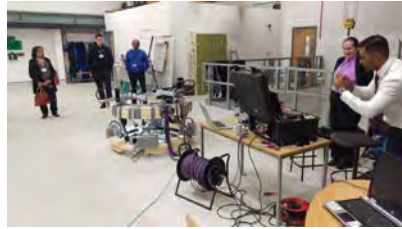
Figure 7 - Testing area and command station deployed at TWI Middlesbrough

The command station was set up next to the test tank at TWI Middlesbrough and a split screen display was set up to view the video from Figure 7. Compressed air was connected to the enclosures via a regulator, set to 0.3 Bar. Using winch straps connected to the eyebolts of the platform, the TWI staff picked up and slowly lowered the platform into the tank.

a. Command station

b. Testing and preparation area
